NAVAL AVIATION

Jets on Carriers  
Weather Squadron  
Post War Fleet

**April 1947**  
RESTRICTED

# JETS ON CARRIERS

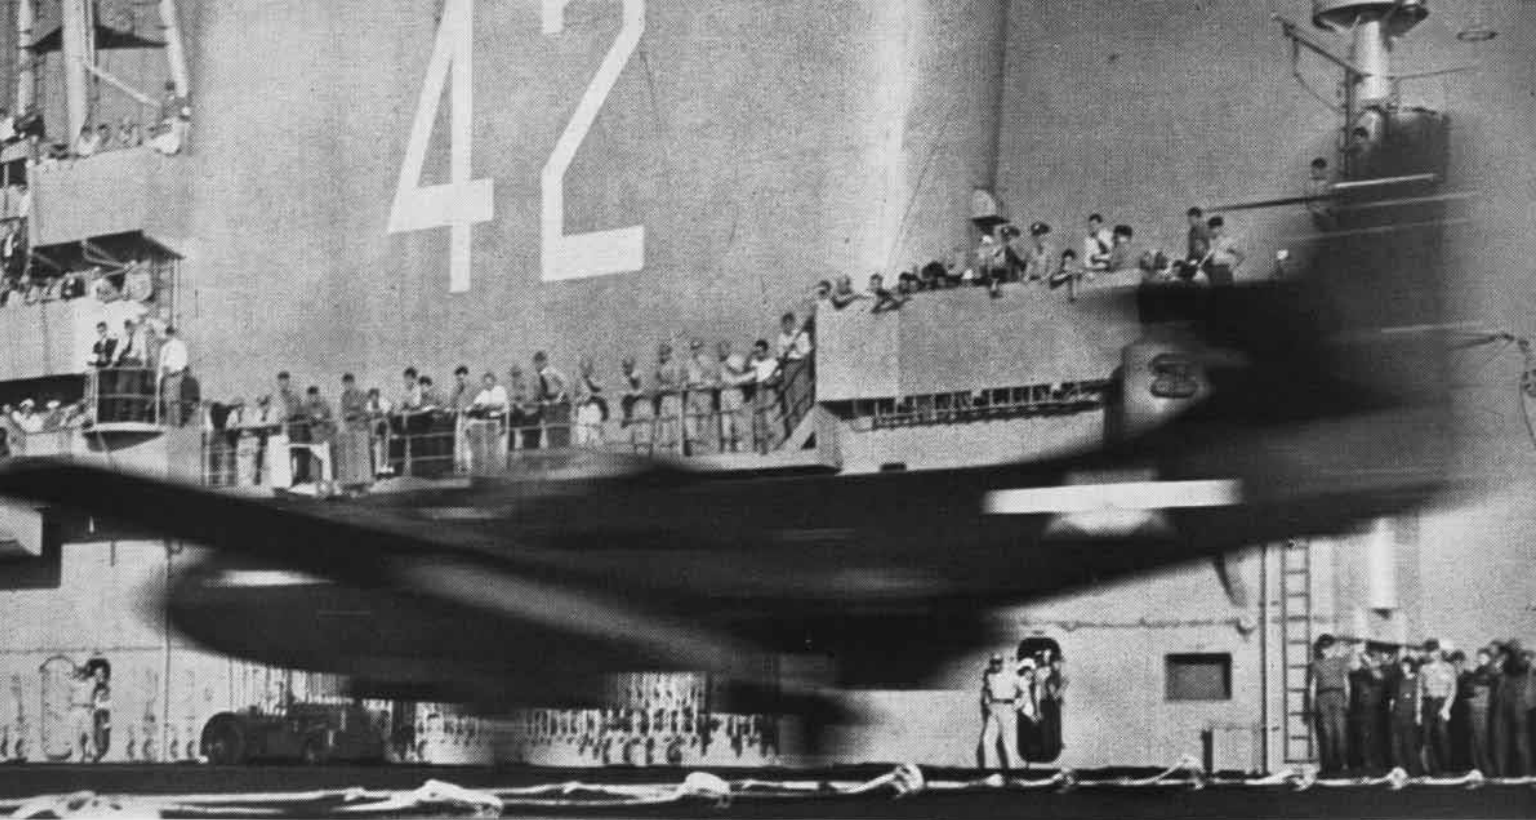
PHANTOM JUST A BLUR OF SPEED AS IT STREAKS PAST THE ISLAND OF THE USS ROOSEVELT ON ITS FIRST CARRIER TAKE-OFF

The *Phantom* experienced no difficulty in taking off the carrier FDR during its initial tests. Its take-off run is no longer than that of some current reciprocal powered

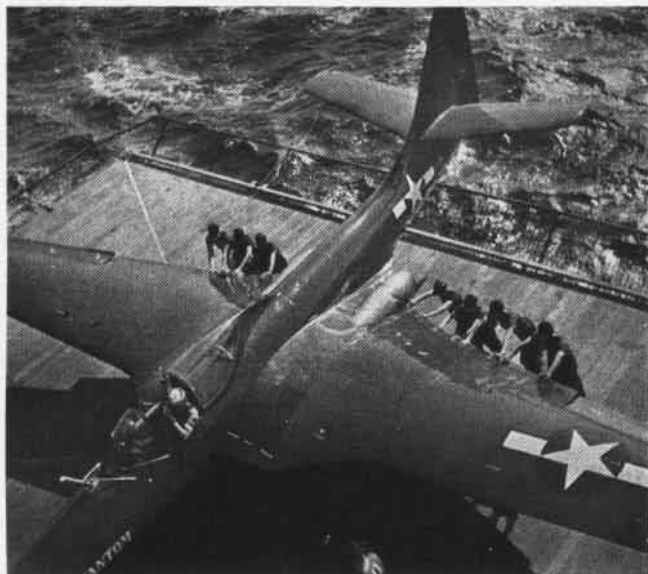
BRINGING FD-1 TOPSIDE VIA SIDE ELEVATOR OF U.S.S. ROOSEVELT

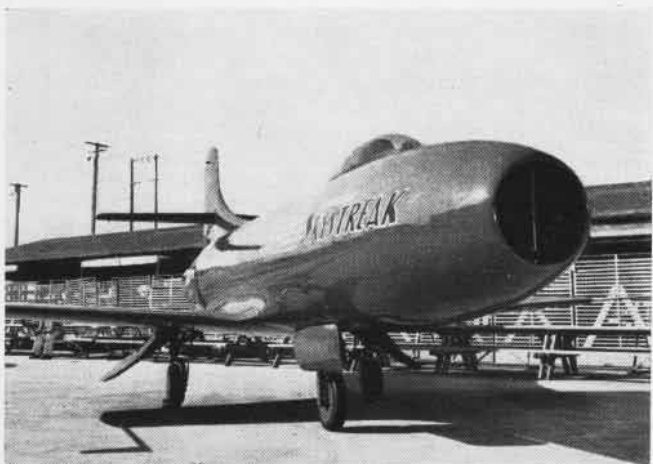
SLEEK SKIN OF TRANSONIC PLANE APPARENT IN THIS NOSE VIEW

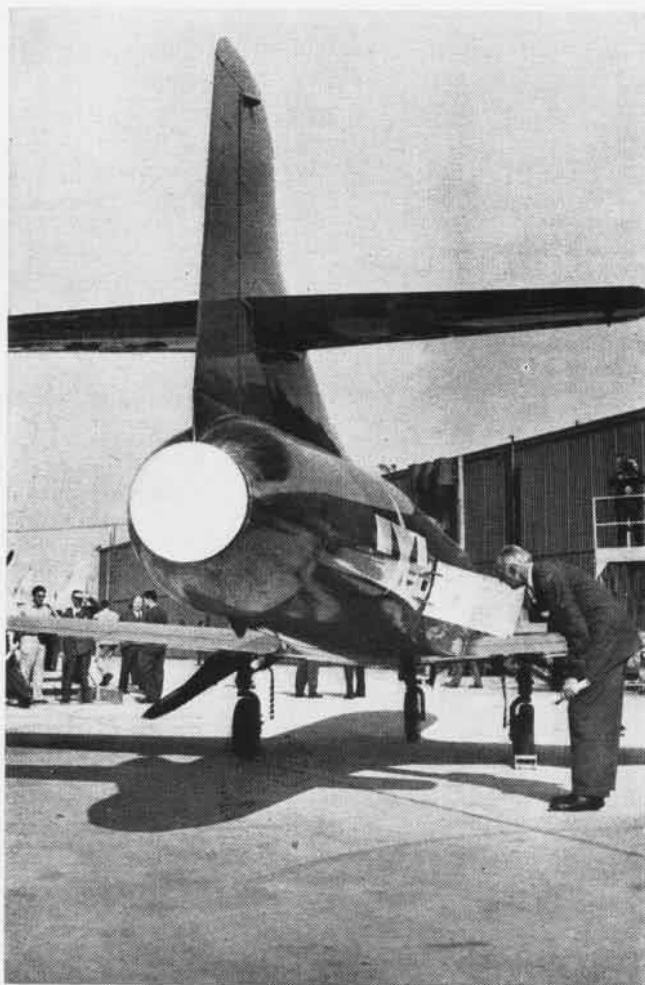
CIGAR-SHAPED FUSELAGE, HIGH RUDDER FEATURE 'SKYSTREAK'

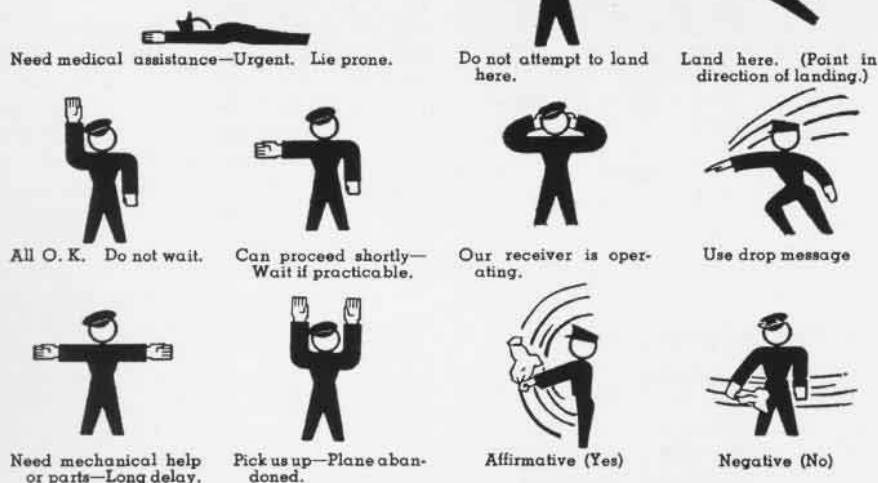
## Body Signals

## NEW SIGNALS AID IN RESCUE

A THIRD type of survival and rescue signals has been announced by Airborne Equipment division of BUAER to supplement the life raft paulin signals and ground/air emergency code previously reported. The new ones involve a series of signs which a downed aviator can use to convey his wants to a rescuing plane overhead.

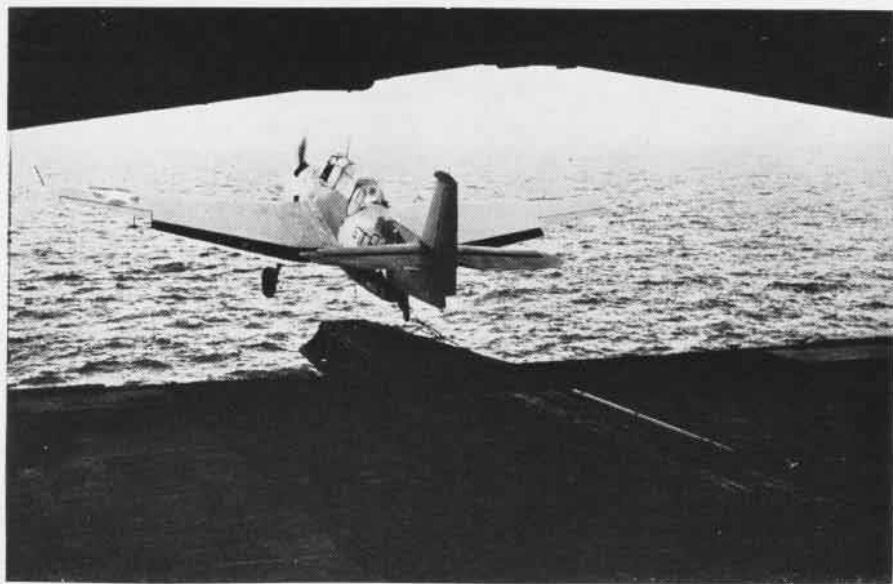
Some Doubt exists in the minds of newer members of the aviation Navy whether aircraft ever were launched athwartships on carriers. Old hands can remember well such scenes as this TBF leaving the H2 catapult on the old Yorktown. The catapult could toss off a plane either to starboard or port. The Enterprise and old Wasp also had hangar deck catapults and some CV's had H4's but they were abandoned because of crosswind launching difficulties and pilots' dislike and both catapults were put on the flight deck.

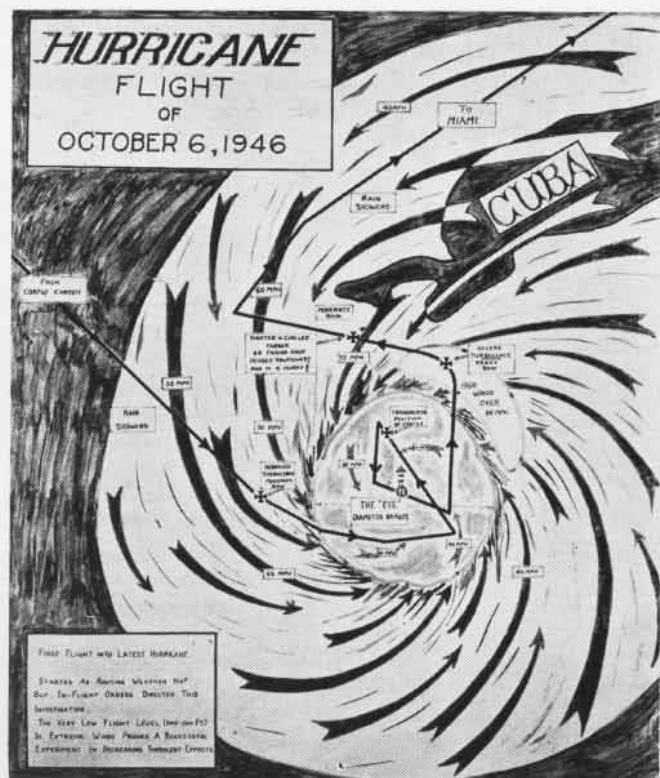
VPM-3 CHARTED ITS HURRICANE PATROL FLIGHTS IN VIVID DETAIL

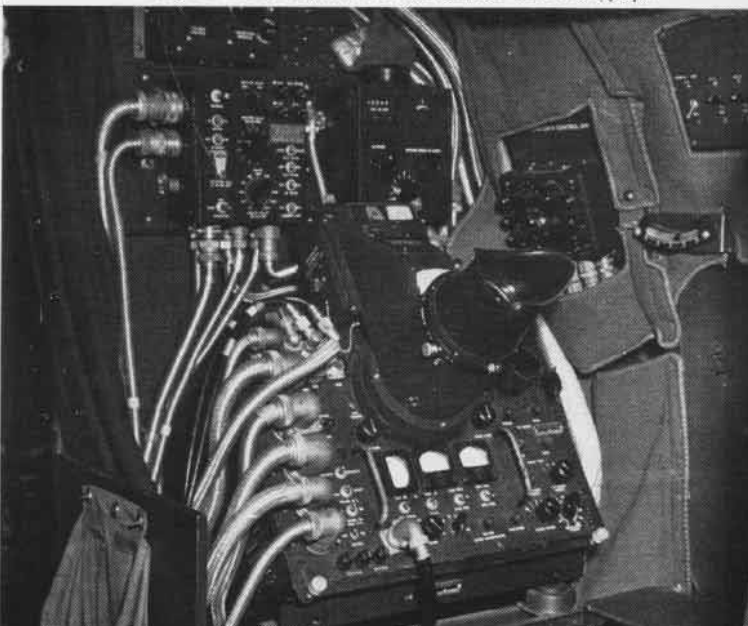
Within close reach of aerologist's table are the radio altimeter, pressure altimeter, 24-hr. clock, aneroid barometer and aerograph

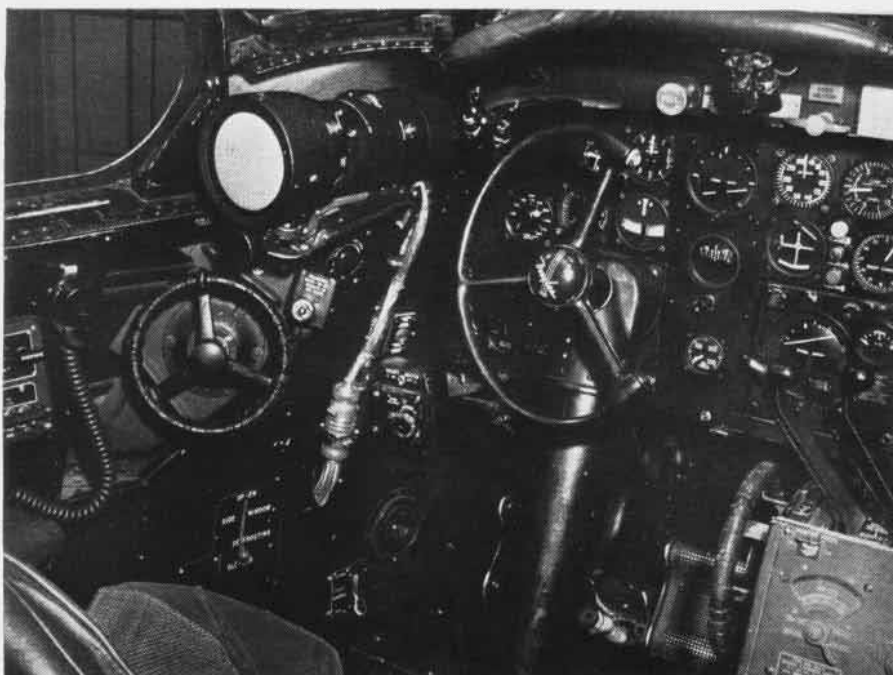
AIRLINER PILOT CAN KEEP ONE EYE ON SCOPE; PPI LOCATED ON CO-PILOT'S SIDE TOO

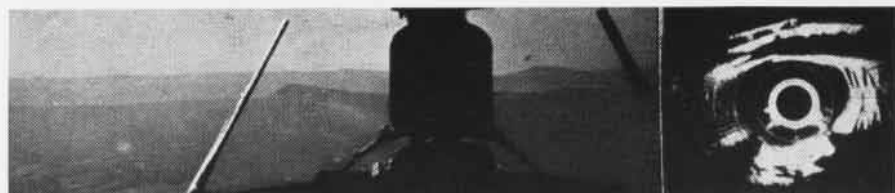
SCOPE AND WINDSHIELD SHOW SAME PICTURE AS RIDGE AHEAD NEARS SACRED CIRCLE

On instruments at 9000 ft., an antenna tilt of -8° to -10° provided 10 mile safety circle. Noted bright target at 15 mile range 30° off port bow. Knowing mountains to be on starboard side (checked by radar and radio fixes) headed plane through echo now shown to be from six to eight miles deep.

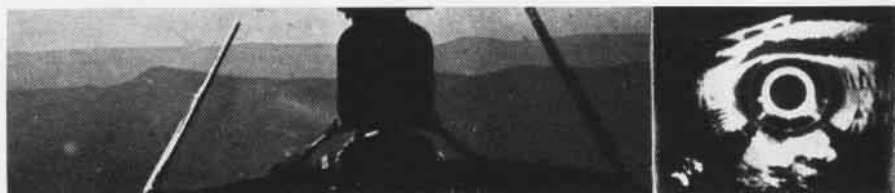
NOW'S TIME FOR PILOT TO ACT; SCOPE SHOWS RIDGE ALREADY INVADING SAFETY CIRCLE

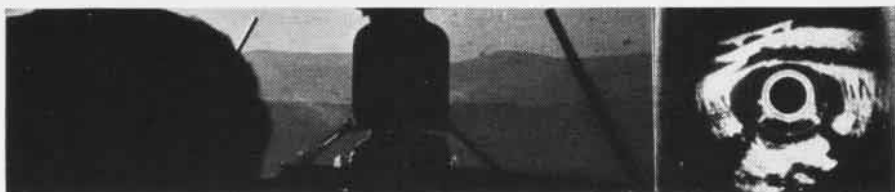
EVASIVE ACTION NEEDED! RANGE  $1\frac{1}{4}$  MILES, PLANE MAY SKIM RIDGE BUT IT'S CLOSE

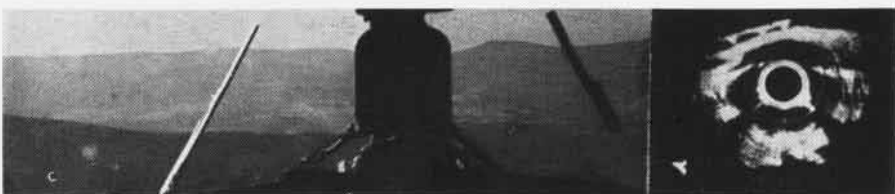
CIRCLE CLEARS AS PLANE SKIMS RIDGE; HILLS STILL CAN BE SEEN THROUGH WINDSHIELD

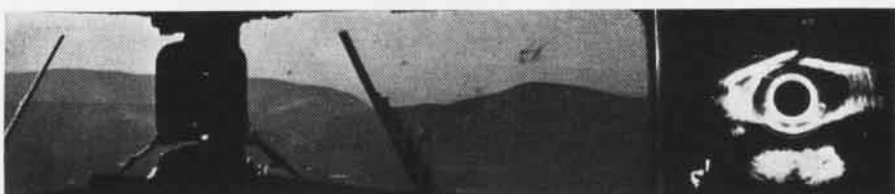
ANOTHER RIDGE LOOMS DEAD AHEAD BUT RADAR SCOPE SHOWS SAFE PASSAGEWAY THRU

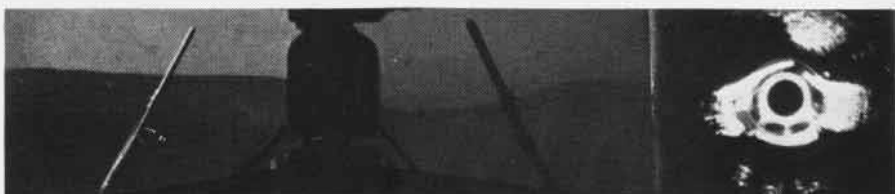
RIDGE NOW WELL INSIDE TWO MILE SAFETY CIRCLE; SCOPE SAYS SAFE PASS  $10^{\circ}$  TO RIGHT

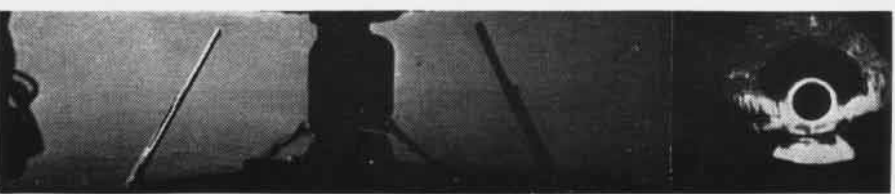
SAFETY CIRCLE CLEARS ON SCOPE AS RADAR EQUIPPED LINER SAFELY SKIMS THROUGH

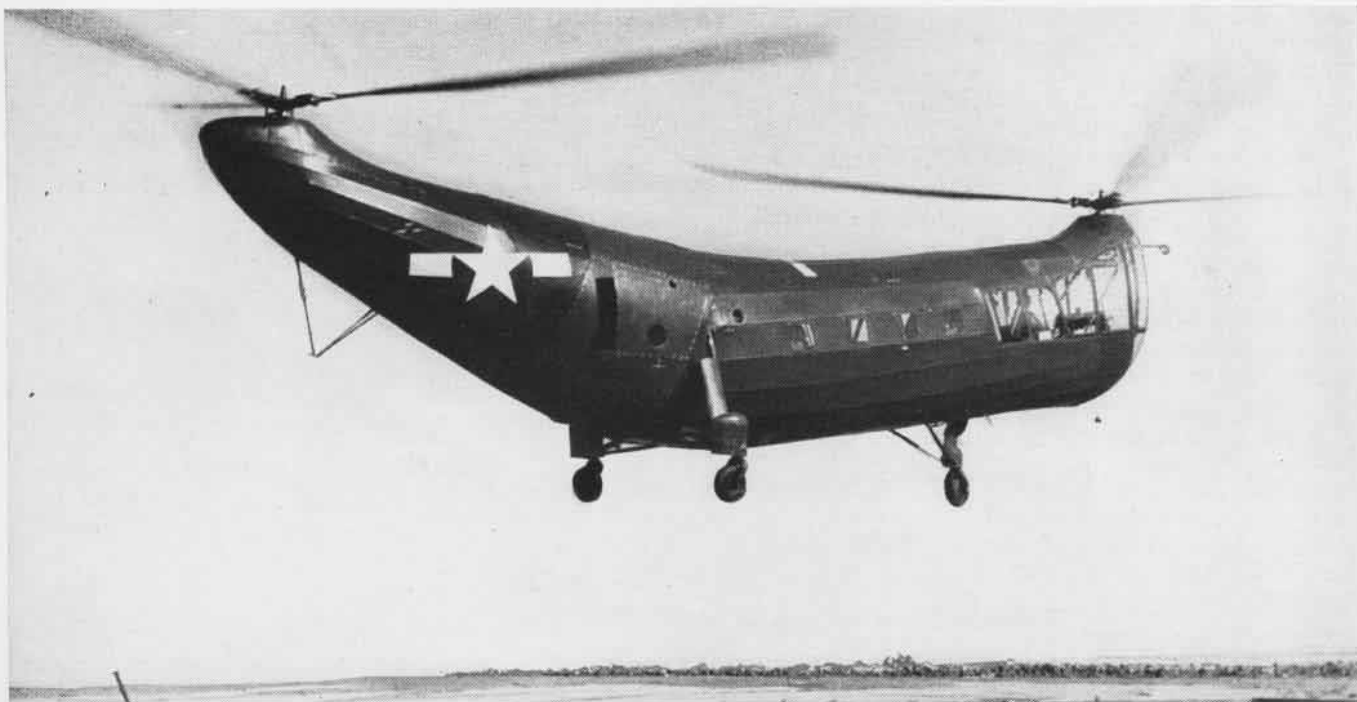
PIASECKI HELICOPTER, PIONEERED BY NAVY, IS FIRST TANDEM MODEL TO FLY; CAN LIFT 10 PERSONS, INCLUDING CREWMEN

Ten of the XHRP-1 type helicopters are being procured for evaluation and operational use. Potential uses for a large helicopter are troop carrying, cargo transport, search and rescue, anti-submarine warfare, air observation, ship-shore communications, personnel transfer and general utility.

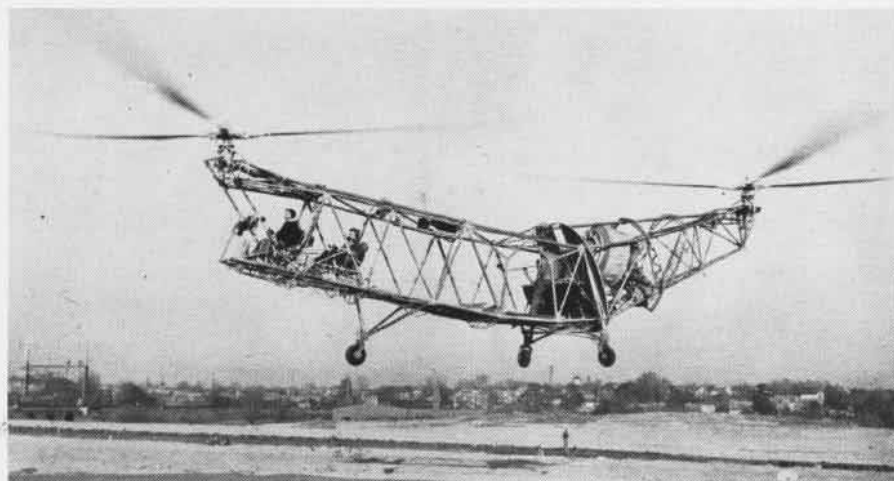
STRIPPED DOWN STATIC MODEL WITH ENGINE IN CENTER HOVERS FEW FEET OFF GROUND

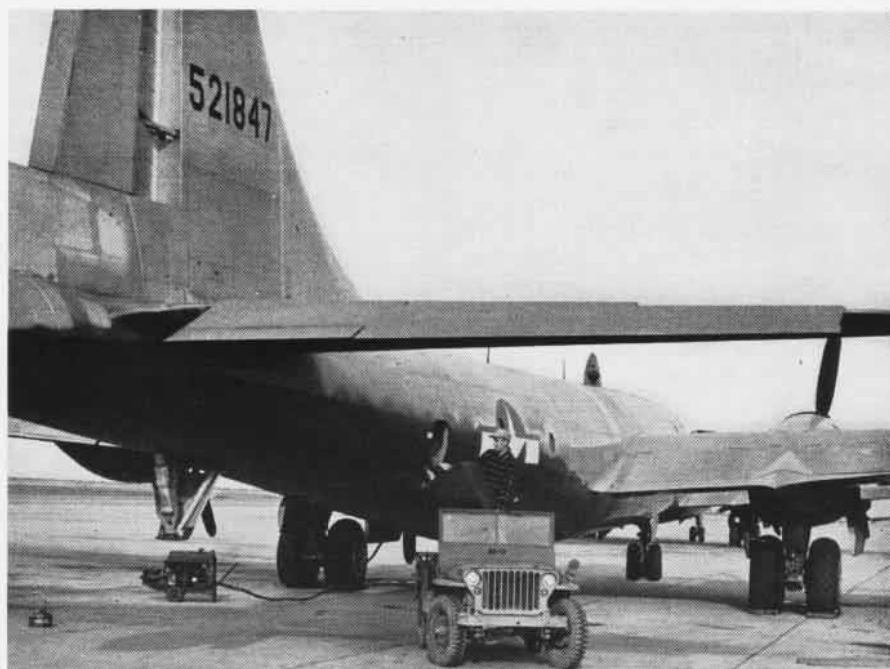
TECHNICIAN LOADS EQUIPMENT INTO B-29 WHICH CARRIES PHYSICISTS IN UPPER AIR

Besides these studies, the Navy's upper atmosphere research program includes spectroscopic measurements, infrared measurements, studies in photometry and sky brightness, meteorology coronagraphic recordings, terrestrial magnetism and electricity and atmospheric composition measurements.

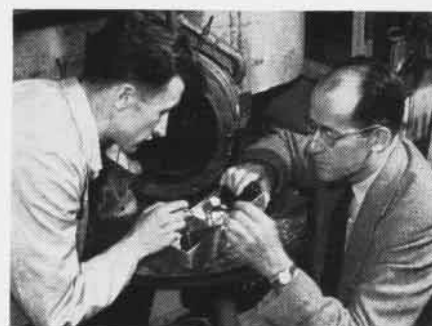
SCIENTISTS PREPARE COSMIC RAY CAMERA

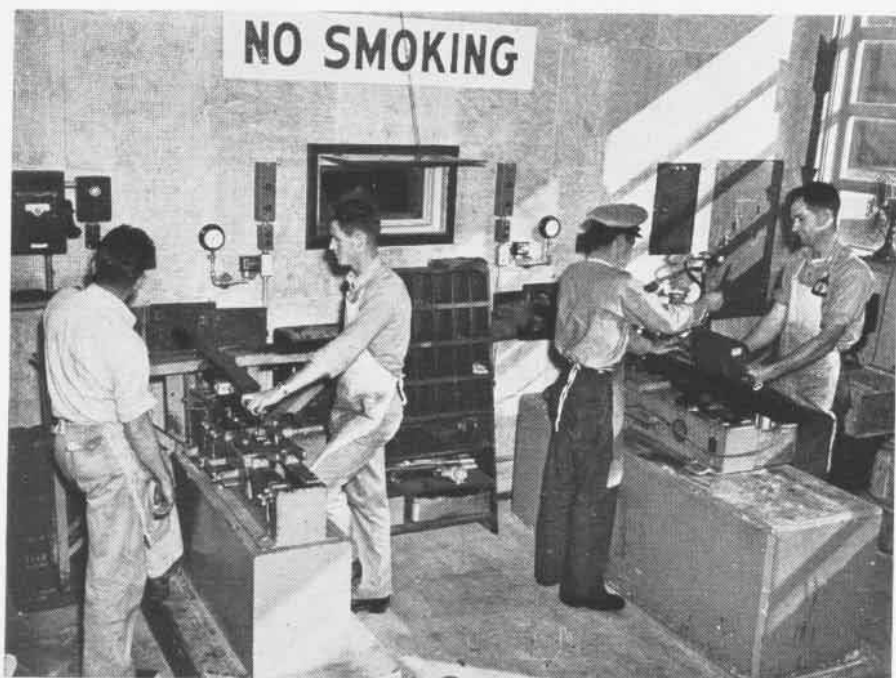
ORDNANCEMEN PREPARE .50 CAL., 20 MM. FOR FIRING THROUGH NOVEL WATER TARGETS

## INDOOR FIRING RANGE BOASTS WATER TARGET

Proof firing from two stations in the old indoor range was a tedious job because the large sand-filled bunker used to stop the bullets needed constant replacement. Pellets pounded the sand into a hard rocky mass causing dangerous ricochets.

As a result of the high velocity of water injection, it is exhausted only at the end of the tube extending into the old sand bunker and no water flows from the end nearest the gun. Water in the tube absorbs most of the energy from the high velocity bullets and they are discharged along with the stream into the bunker room.

Here the spent pellets clatter harmlessly against the armor plate lining the wall and fall to the deck where they are washed by the water flow into the sump pit. A screen retains the pellets in the sump, keeping them from being picked up in the recirculating pump suction. At intervals the accumulation

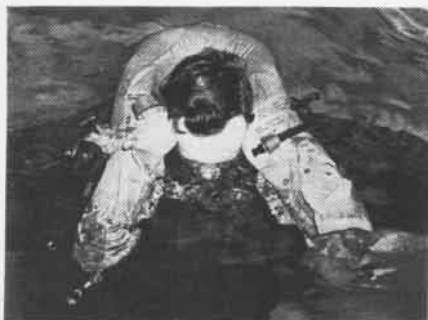
Subsequent tests conducted by the squadron showed that on a large percentage of the vests the snaps popped open when the CO2 toggles were pulled.

TEST SHOWS PERIL AS VEST PULLS OPEN

in the production of the life vests, and action was taken to have the contractor install the large lift-the-dot fasteners.

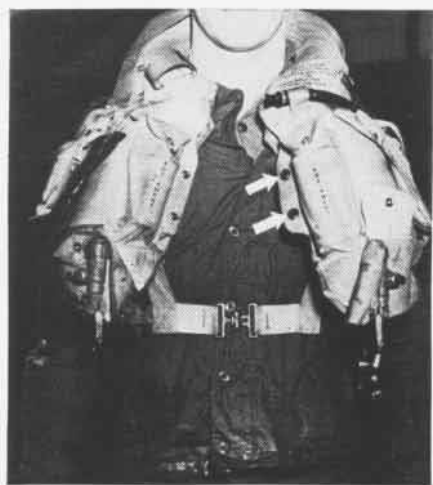
FASTENERS FAIL TO HOLD ON VEST LOBES

BuAer Technical Order 45-46, dated 19 December 1946, provided for the modification on vests previously delivered to service activities. Compliance with this directive will obviate the danger.

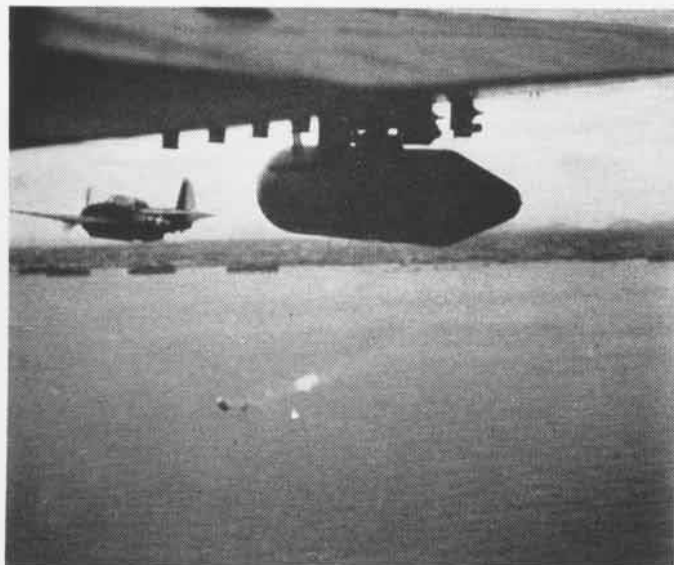
RAFT AND RATIONS FALL AS CHUTE OPENS BELOW RESCUING TBM

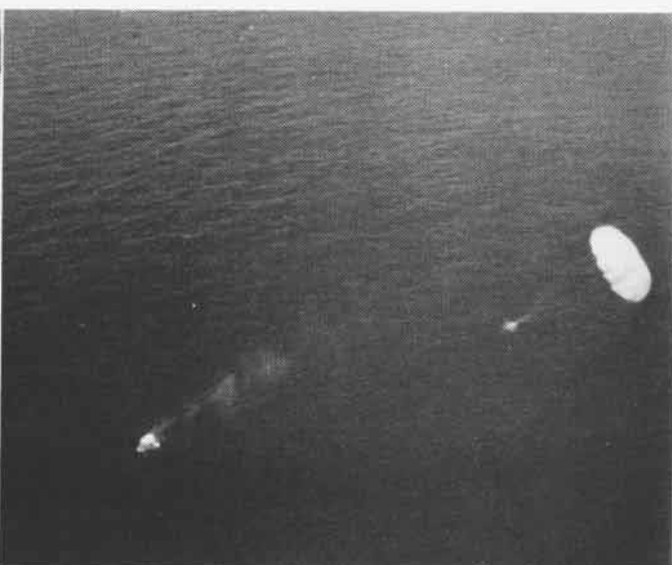
CHUTE SLOWS DROP AS RAFT INFLATES WHEN NEARING WATER

The merits of dropping rafts inflated or deflated is debatable. Believe that deflated drops made at altitude of 50 to 100 feet at IAS 90-100 k. will give better placement and reduce any damage due to impact. When a raft is dropped inflated, even using the Mk 8 chute as an anchor it still can swing around in a 200' radius which might, due to wind and placement, cause it to get away from the survivors. In combat it might be desirable to have the raft land deflated for tactical reasons—and for training purposes believe that all indoctrination should be with the thought of actual combat in mind.

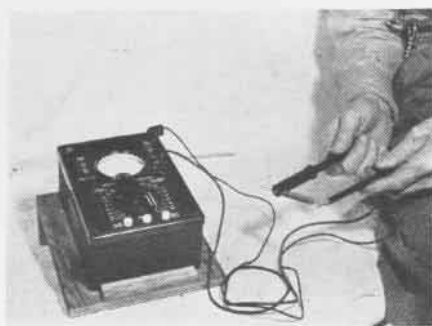
NAVAL GUN FACTORY—A novel test prod, possessing a wire clamping feature that aids in obtaining accurate and reliable information from tests of electrical and electronic equipment, has been developed at this activity through the Navy Employees'

GADGET IS CAPABLE OF CLAMPING WIRE
